**Wetland Delineation Report  
For  
Tubies Site  
Straban Township  
Adams County, Pennsylvania  
Fall 2007  
RETTEW Project No. 07-07964-001**

RETTEW Associates, Inc. (RETTEW) has prepared this wetland delineation report for Mr. George Tubies to document the locations and characteristics of jurisdictional wetland habitats and “waters of the United States”/“waters of the Commonwealth” that exist on his property at 2390 York Road, Gettysburg, PA (Tubies Site). The following information outlines the review of the published resource materials, existing site conditions, and results of the field investigation.

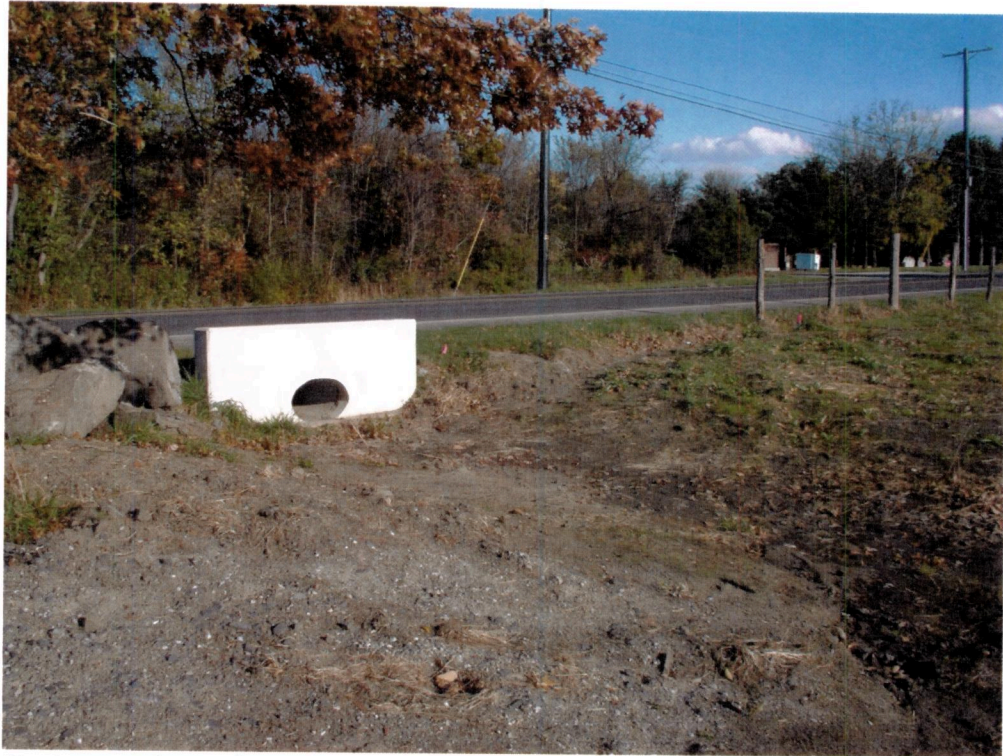
Photo 1 – Facing southeast from near Sample Point #1, viewing Granite Station Road and the culvert that drains Wetland #1.

violation includes restoring this wetland. Wetland #1 drains off-site to the east, through a culvert under Granite Station Road. Wetland #1 contains 1.002 acres within the site.

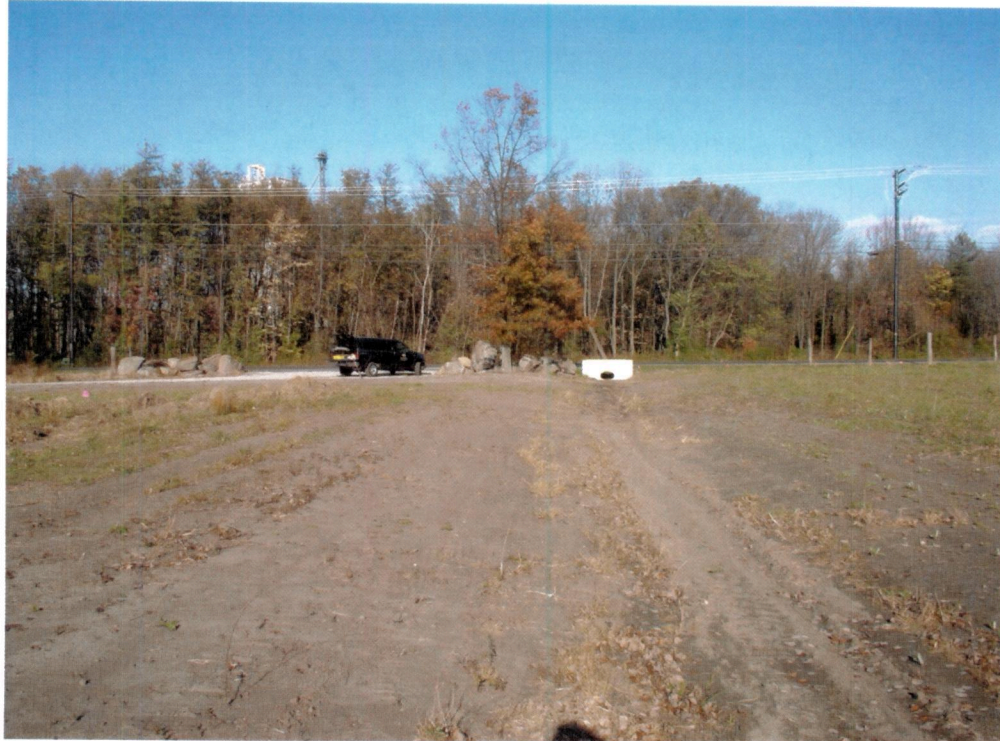
Photo 2 - Facing east from the man-made swale that drains Wetland #1. This bare earth/ recently graded swale is typical of the habitat found within Wetland #1.

Wetland #1 is identified as a palustrine emergent (PEM) wetland. This wetland includes a swale that drains the pond located around the center of the site. Wetland #1 has undergone significant disturbance and is the subject of the violation that occurred on the property. Resolution of the

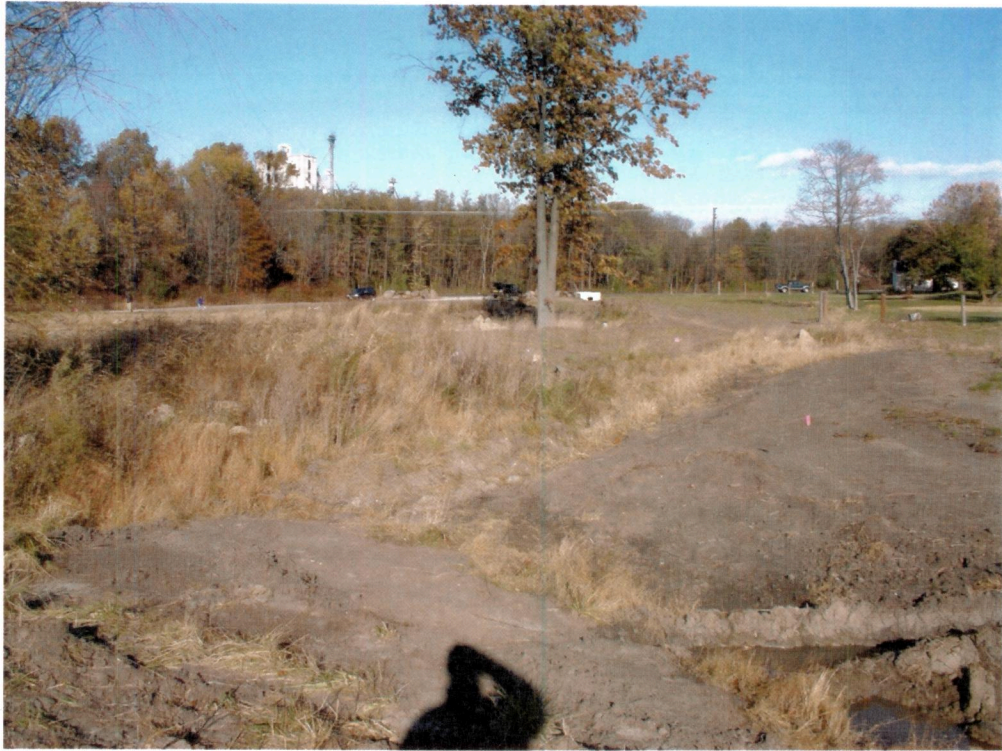
Photo 3 - Facing east from the eastern pond berm, viewing the top of the swale included within Wetland #1.

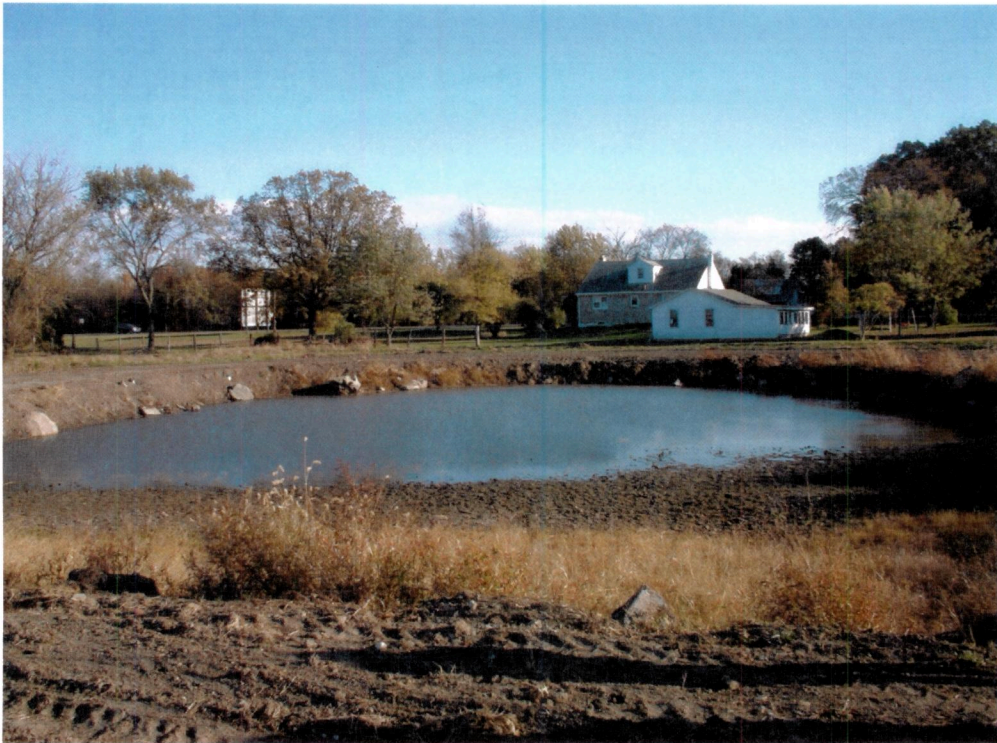
Photo 4 - Facing south from around the center of the site, viewing the pond that drains into Wetland #1.

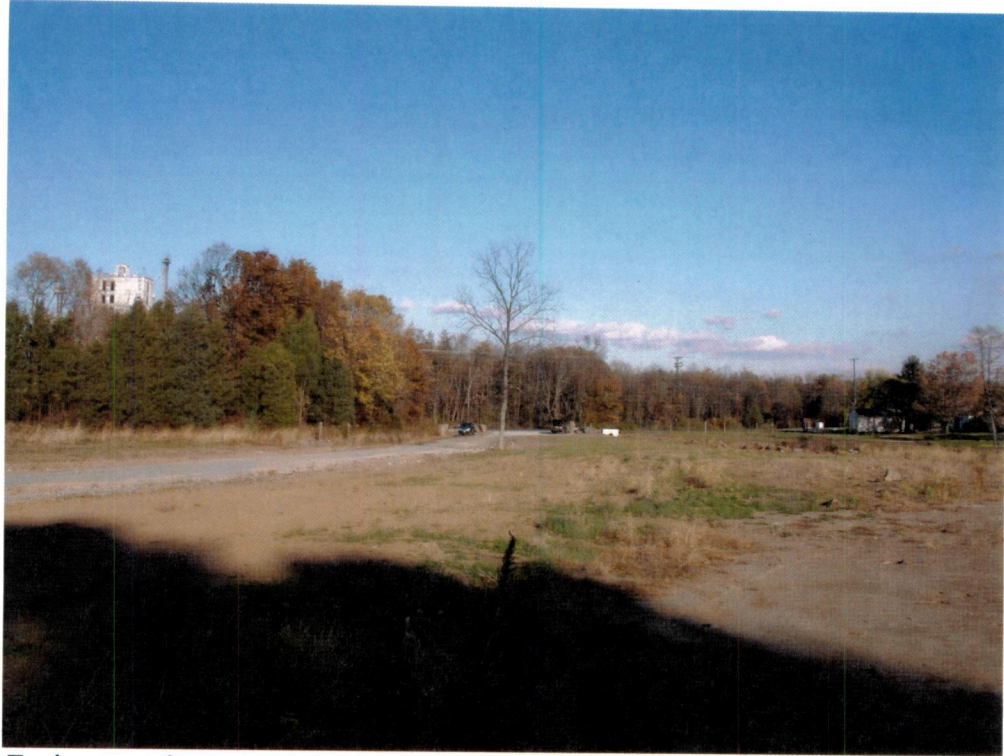
Photo 5 – Facing east from around the center of the site, viewing the existing stone lane and disturbed uplands that lie to the north of Wetland #1.

Sample Points #3 & 11 were located in disturbed upland areas adjacent the swale identified as Wetland #1. Similar to the wetland sample points, the vegetation and hydrology at these two points were disturbed. The dominant vegetative species were *Cirsium arvense*, *Rumex crispus*, *Plantago lanceolata*, *Setaria faberi*, *Physalis subglabrata* (ground-cherry, NI), and *Taraxacum officinale* (common dandelion, FACU-). The soil is mapped as WaA. See the data sheets in Appendix A for the soil descriptions of each point. Both points lacked any primary or secondary indicators of wetland hydrology. Based on the lack of dominant hydrophytic vegetation, lack of

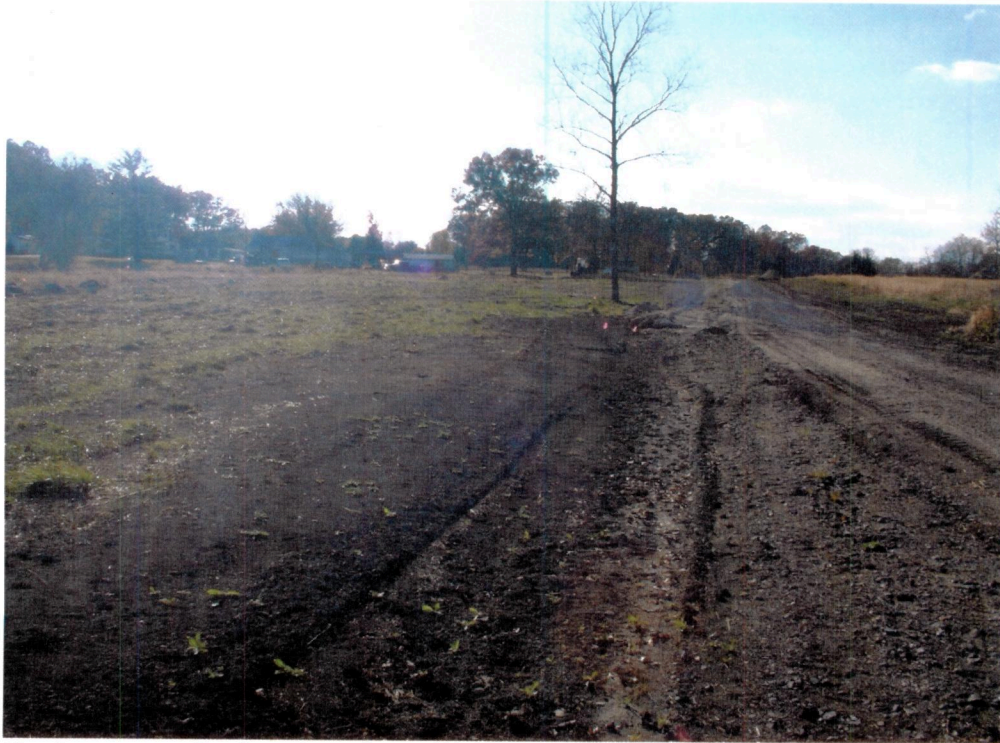
Photo 6 – Facing west, viewing the upper, northwestern extent of Wetland #1, adjacent the existing stone driveway.

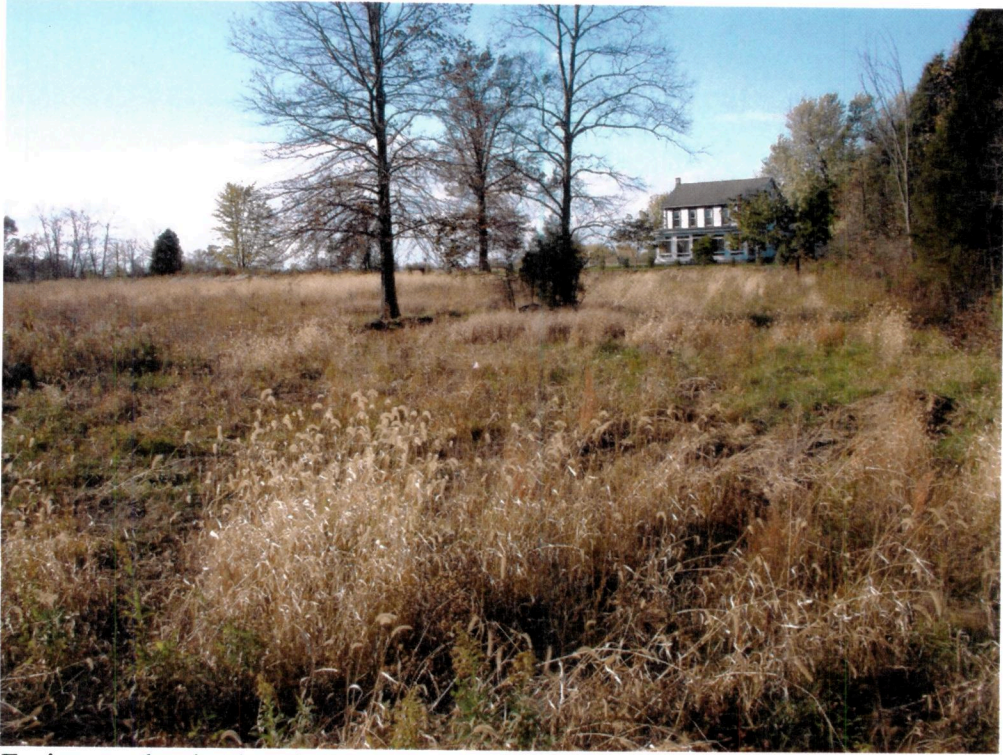
Photo 7 – Facing north, viewing the low-lying area identified as Wetland #2 that is situated in a fallow field on the north side of the site.

Sample Point #12 was located in a fallow field area north of the constructed stone driveway on the north side of the site. The dominant vegetative species were *Scirpus cyperinus*, *Cornus racemosa* (grey dogwood, FAC-), *Agrimonia parviflora* (harvestlice, FAC), *Agrostis alba* (redtop, FACW), *Ulmus rubra* (slippery elm, FAC), *Setaria faberi* and *Vernonia noveboracensis* (New York ironweed, FACW+). The soil is mapped as WaA. The A-horizon had a soil matrix color of 10YR 3/1 with no redoximorphic concentrations at a depth of 0 to 18 inches. The soil profile consisted of a dry clay loam. Primary indicators of wetland hydrology included a wetland drainage pattern. Secondary indicators included oxidized rhizospheres within 12 inches and a positive FAC-neutral test. Based on the dominant hydrophytic vegetation, hydric soil characteristics and primary and secondary indicators of wetland hydrology, Sample Point #12 was determined to be within a PEM wetland.

Wetland #2 is identified as a PEM wetland that is located in a low-lying area within a fallow field north of the driveway on the north side of the site. The wetland continues offsite to the east and contains 0.105 acres within the area of investigation.

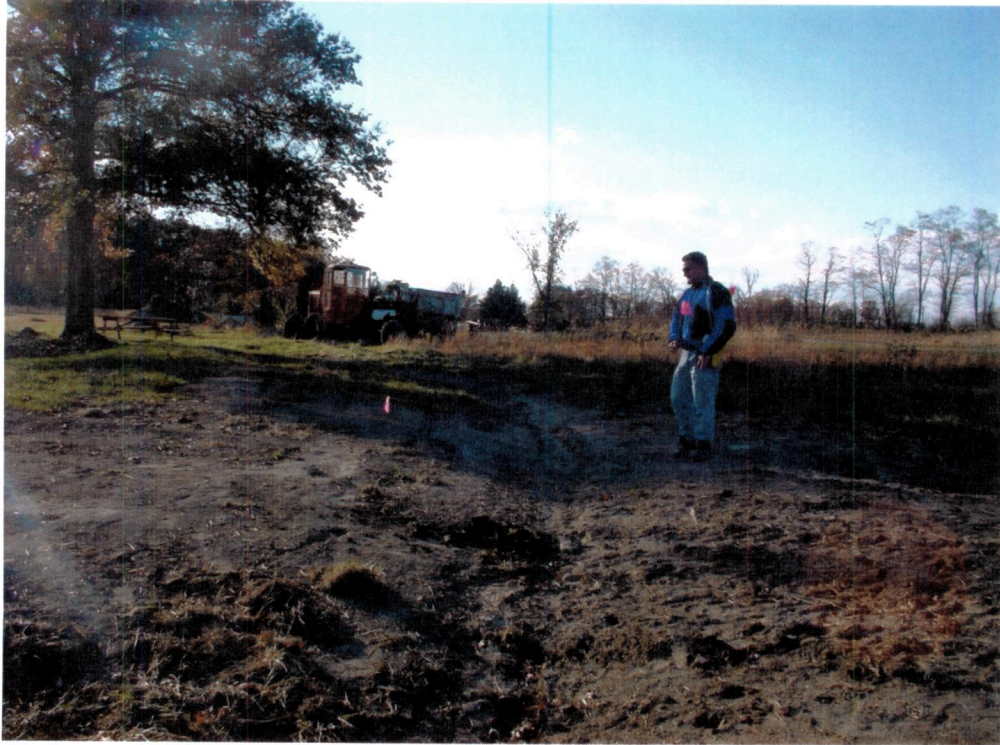
Photo 8 – Facing west from the pond, viewing the graded, upland swale that drains the surrounding uplands into the pond.

Sample Point #13 was located within a graded wet swale that drains into the west side of the pond, around the center of the site. The dominant vegetative species was *Plantago lanceolata*. The soil is mapped as WaA. The A-horizon had a soil matrix color of 10YR 3/2 with no redoximorphic concentrations at a depth of 0 to 6 inches. The B-horizon had a soil matrix color of 10YR 3/2 with common, distinct 5GY 3/1 redoximorphic concentrations at a depth of 6 to 18 inches. The soil profile consisted of a dry clay loam. There were no primary or secondary indicators of wetland hydrology. Based on the lack of dominant hydrophytic vegetation and lack of primary or secondary indicators of wetland hydrology, Sample Point #13 was determined to be within a nonwetland area.
